ECCC Founder's Gymnasium

Existing Building Report and Recommendations

June 14, 2011

BELINDA STEWART ARCHITECTS, P.A.

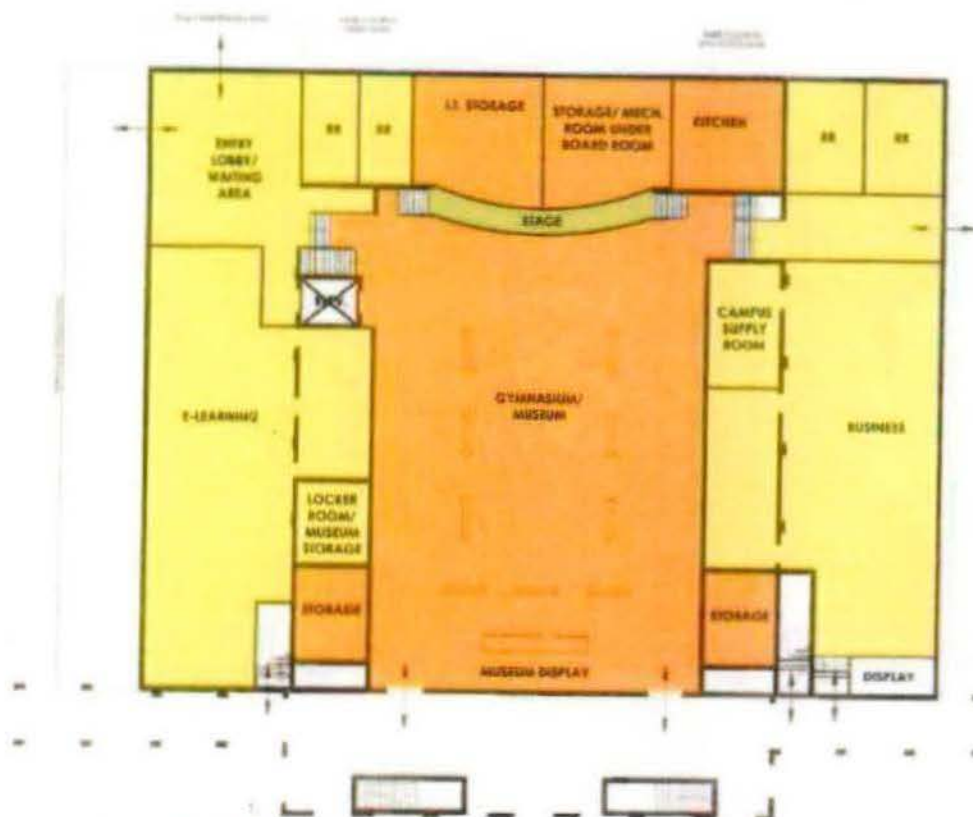
FIRST FLOOR PLAN

Floor Plan Legend	
	0'-0" 1st Floor
	3'-3" Gym Floor
	7'-3" Stage
	11'-0" 2nd Floor
 →	Image Views Key
